Models Affected: DN5800-3 & 4, DN3800-3 & 4

Product Notice

Models Affected: Model DN5800-3 & -4 and DN3800-3 & -4 **Release Date: April 2019**

Subject: Fluorescent Ballasts in BevMAX Machines

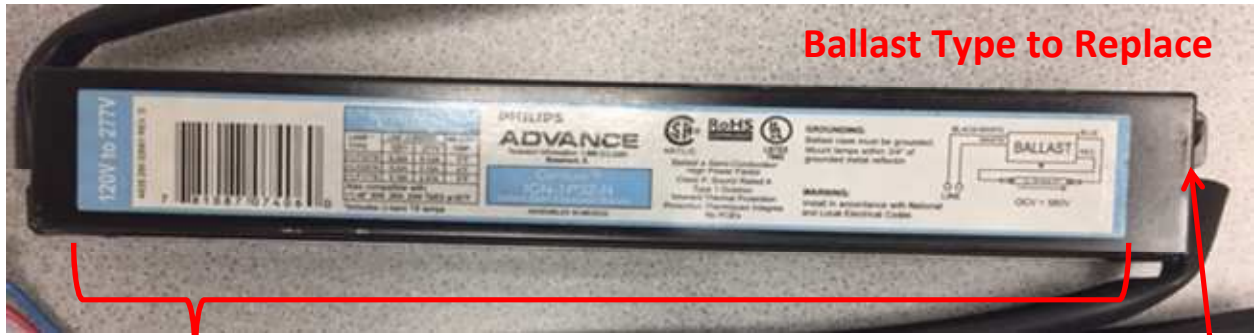
Ballast Type to Replace

Full length label

Date code appears stamped on rear of metal case

ICN ballasts with these identifying features **MUST** be removed and replaced:

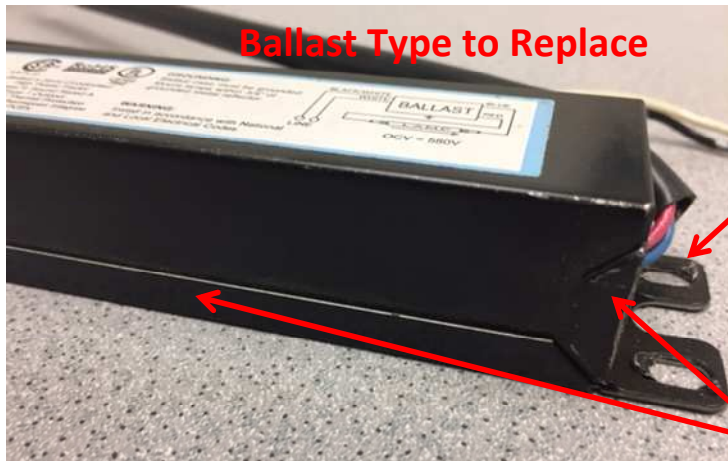
Ballast Type to Replace

Holes for attachment in end

Flanges on bottom of case

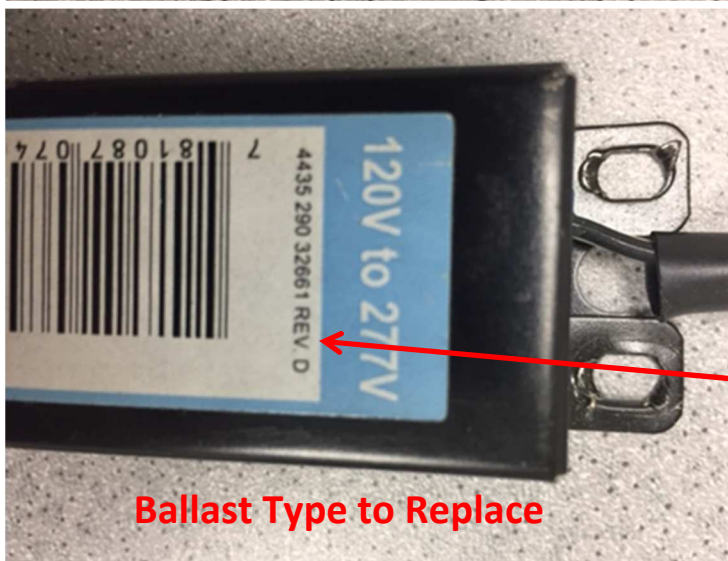
Ballast Type to Replace

"Rev D" identification

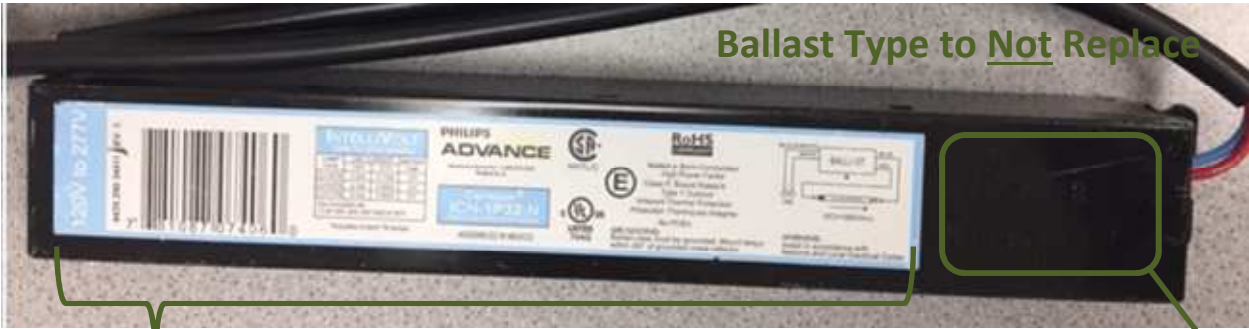
Ballast Type to Not Replace

Shorter length label

Date code appears stamped on front of metal case

ICN ballasts with these identifying features DO NOT need to be removed and replaced:

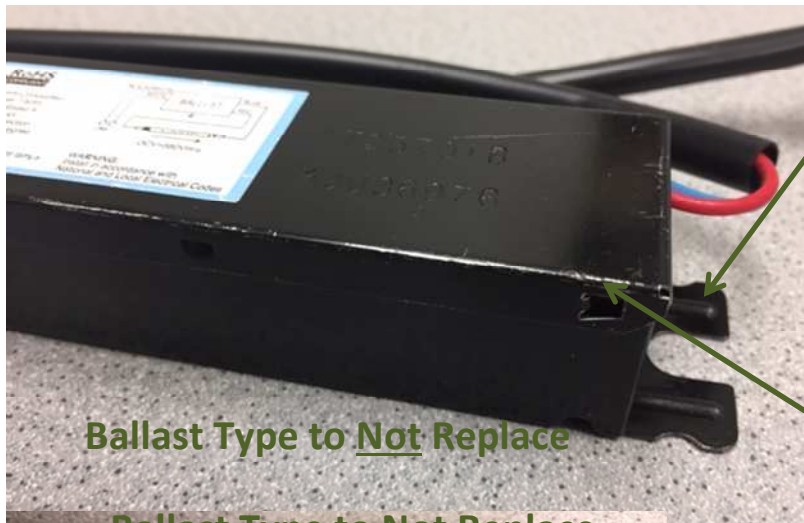
Ballast Type to Not Replace

Attachment no longer has hole

Case cover snaps on top

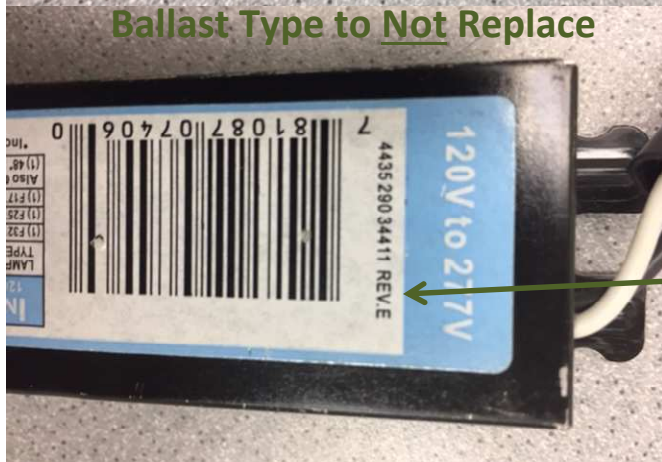
Ballast Type to Not Replace

"Rev E" identification
